**Flood Control Project Maintenance  
Levee Inspections**

**Fall 2016 Levee Maintenance Deficiency Summary Report**

**Reclamation District No. 2085 Kasson**

**Levee Inspection Report By Mile - Fall 2016**

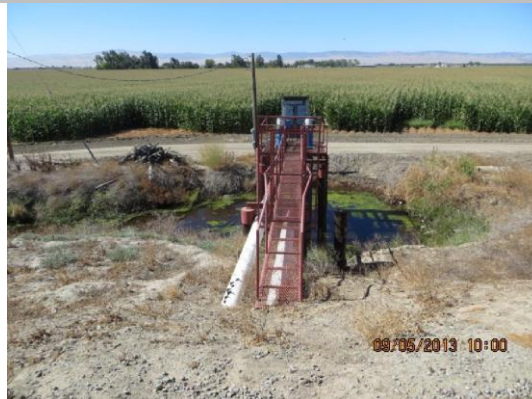
Photo 2 of 2 : UCIP\_FA\_2016\_22285\_38009.jpg

FS\_ID:22285  
DS\_ID:24055  
EP\_NO: N/A  
Repair Type: Non-Urgent  
Crossing Status: Found  
UCIP Comments: No permit identified for this modified crossing.  
FIELD\_STRUCT\_DESC: 12-inch steel pipe through the levee 3-feet below the crown. Pump mounted on pile structure in ditch on the landward side. Siphon breaker in 12-inch steel riser unit and a gatevalve on the waterward shoulder. (Permit No. 8189, 1972)  
FS Date: 9/10/2013

Pipe, pump, and walkway visible on LS toe.

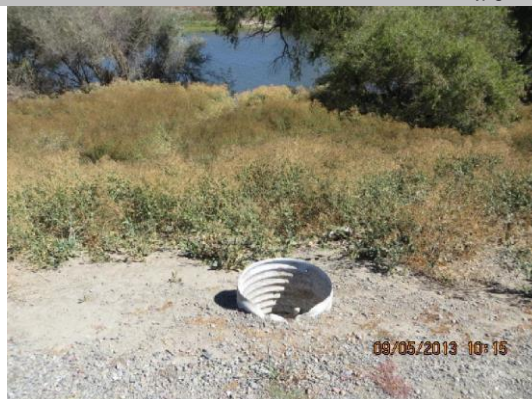
Photo 1 of 2 : UCIP\_FA\_2016\_41351\_62268.jpg

Comment Code					
Inspector Comment					
FS_ID:41351					
DS_ID:20679					
EP_NO: 3975					
Repair Type: Non-Urgent					
Crossing Status: Found					
UCIP Comments: Pipe abandoned and should be done so properly.					
Large hole in ground over pipe on WS berm. Pipe rusted through on					
WS at river bank. No connection to pump on LS toe.					
FIELD_STRUCT_DESC: *ABANDONED* 10-inch steel stormdrain pipe					
through the levee 4-feet below the crown. Steel plate over pipe end at					
pump station on LS toe. Siphon breaker in 24-inch corrugated metal					
riser unit on the waterward shoulder (Permit No. 3975, 1962). Originally					
included in the 1968 O&M manual.					
FS Date: 9/5/2013

Siphon breaker in 24-inch CMP riser on WS shoulder.

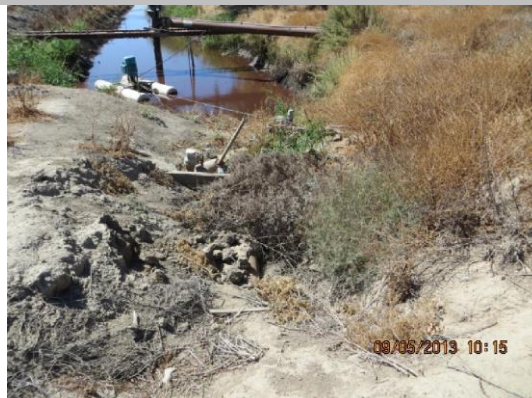
Photo 2 of 2 : UCIP\_FA\_2016\_41351\_62267.jpg

Pipe visible at bottom of ditch on LS toe.

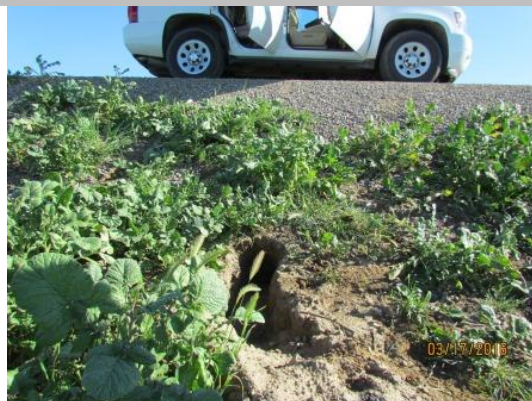
Photo 1 of 1 : FA\_2016\_RD2085\_113\_39\_20160914\_00016.jpg

LM Start	1.79	Rating **	M	Issue No.	39
LM End	1.79	Issue Type +	Ma	Location *	WS
Category	Earthen Levee			GPS Latitude/Longitude	
				Start	End
Item	Animal Control			37.711456 °	37.711456 °
				-121.282397 °	-121.282397 °
DWR ID	DWR_RD2085_01_s_ 2016_39				
Comment Code					
A3 : No rodents visible, but rodent burrows visible; need to backfill and compact or grout burrows.					
Inspector Comment					
LMA has bait stations on the levee.

View of the rodent burrows on the landside levee slope.

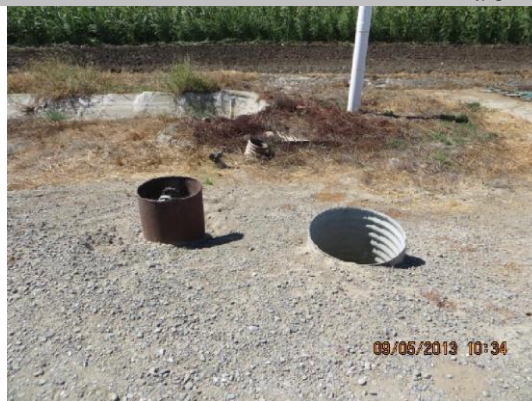
Photo 1 of 2 : UCIP\_FA\_2016\_19423\_32962.jpg

LM Start	2.04	Rating **	M	Issue No.	55
LM End	2.04	Issue Type +	En	Location *	WS
Category	Supplemental			GPS Latitude/Longitude	
				Start	End
Item	DWR UCIP Field Study			37.708826 °	37.708826 °
				-121.279271 °	-121.279271 °
DWR ID					
Comment Code					
Inspector Comment					
FS_ID:19423 DS_ID:20681 EP_NO: N/A Repair Type: Non-Urgent Crossing Status: Found UCIP Comments: This pipe is abandoned and should be done so properly. FIELD_STRUCT_DESC: 1 of 2: 10-inch pipe through the levee 2.0-feet below the crown. Pump mounted on pile structure in the river. Siphon breaker in 24-inch CMP riser on the LS slope. Power pole on LS toe. Wooden stairs and walkway from the berm to the pump structure. Originally included in the 1968 O&M manual. FS Date: 9/5/2013 8:22:24 AM

Siphon breaker in 24-inch CMP riser on LS slope. Possible gate valve at end of concrete channel on LS toe.

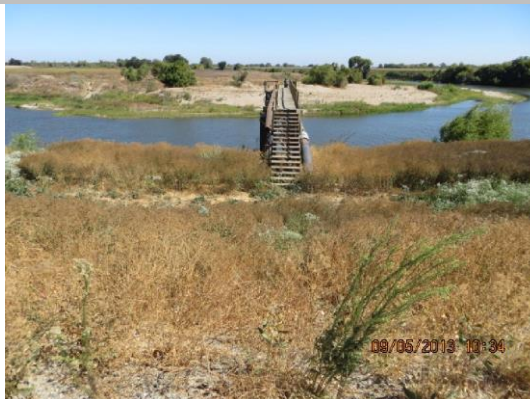
Photo 2 of 2 : UCIP\_FA\_2016\_19423\_32961.jpg

LM Start	2.04	Rating **	M	Issue No.	55 (cont)	
LM End	2.04	Issue Type +	En	Location *	WS	
Category	Supplemental			GPS Latitude/Longitude		
				Start	End	
Item	DWR UCIP Field Study			37.708826 °	37.708826 °	
				-121.279271 °	-121.279271 °	
DWR ID						
Comment Code						
Inspector Comment						
FS_ID:19423 DS_ID:20681 EP_NO: N/A Repair Type: Non-Urgent Crossing Status: Found UCIP Comments: This pipe is abandoned and should be done so properly. FIELD_STRUCT_DESC: 1 of 2: 10-inch pipe through the levee 2.0-feet below the crown. Pump mounted on pile structure in the river. Siphon breaker in 24-inch CMP riser on the LS slope. Power pole on LS toe. Wooden stairs and walkway from the berm to the pump structure. Originally included in the 1968 O&M manual. FS Date: 9/5/2013 8:22:24 AM

Pipe cut at wooden pier. No pump on end of pier for this pipe.

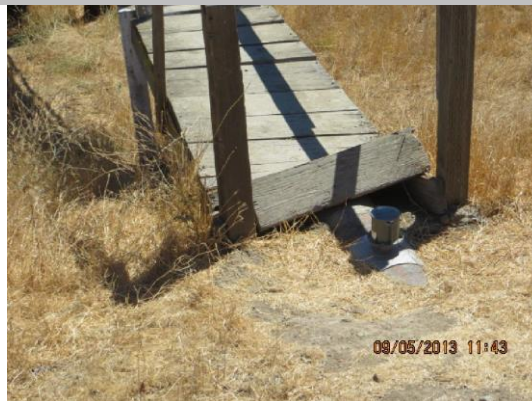
Photo 2 of 2 : UCIP\_FA\_2016\_19431\_32982.jpg

FS\_ID:19431  
DS\_ID:20688  
EP\_NO: 16970  
Repair Type: Non-Urgent  
Crossing Status: Found  
UCIP Comments: The wooden walkway on the WS slope is in disrepair.  
FIELD\_STRUCT\_DESC: 1 of 2: 14-inch steel irrigation pipe through the levee 2.0 feet below the crown. Pump on wooden pier at WS slope.  
Siphon breaker visible next to steel bollard on LS slope. Power pole on LS toe.  
FS Date: 9/5/2013

Pipe visible under walkway on WS slope.

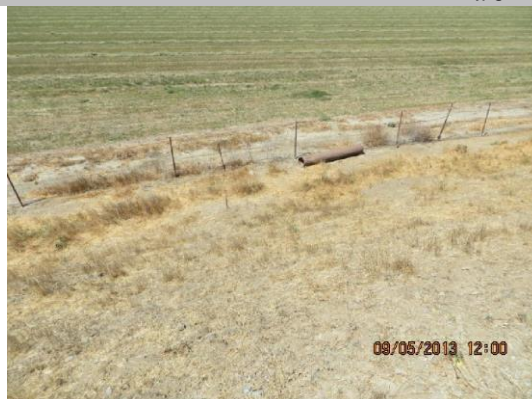
Photo 1 of 2 : UCIP\_FA\_2016\_19433\_32990.jpg

LM Start	3.30	Rating **	M	Issue No.	57
LM End	3.30	Issue Type +	En	Location *	LS
Category	Supplemental			GPS Latitude/Longitude	
				Start	End
Item	DWR UCIP Field Study			37.693618 °	37.693618 °
				-121.277639 °	-121.277639 °
DWR ID					
Comment Code					
Inspector Comment					
FS_ID:19433 DS_ID:20693 EP_NO: N/A Repair Type: Non-Urgent Crossing Status: Found UCIP Comments: Pipe appears abandoned and should be done so properly. FIELD_STRUCT_DESC: *ABANDONED* 10-inch steel stormdrain pipe through the levee 4.0-feet below the crown. T-post marks location of Pipe at LS toe. Steel plate welded over pipe on WS slope. Asbuilts available DWG 7-4-1685. Originally included in the 1968 O&M manual. FS Date: 9/5/2013

T-post marking pipe end on LS toe. 10-inch pipe debris on LS toe.

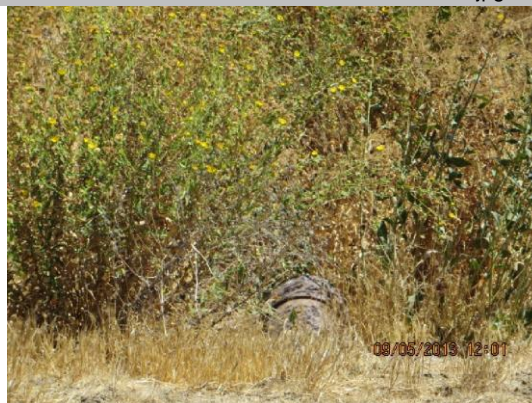
Photo 2 of 2 : UCIP\_FA\_2016\_19433\_32989.jpg

Pipe visible on WS slope.

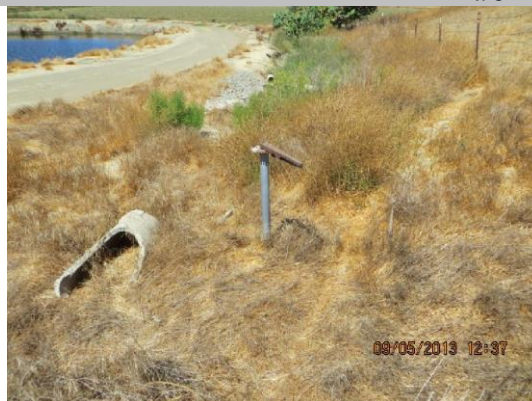
Photo 1 of 2 : UCIP\_FA\_2016\_19435\_32993.jpg

LM Start	3.42	Rating **	M	Issue No.	58
LM End	3.42	Issue Type +	En	Location *	LS
Category	Supplemental			GPS Latitude/Longitude	
				Start	End
Item	DWR UCIP Field Study			37.691966 °	37.691966 °
				-121.278122 °	-121.278122 °
DWR ID					
Comment Code					
Inspector Comment					
FS_ID:19435 DS_ID:20687 EP_NO: 16970 Repair Type: Non-Urgent Crossing Status: Found UCIP Comments: Appears abandoned and if so should be done so properly. FIELD_STRUCT_DESC: *ABANDONED* 2 of 2: 10-inch steel stormdrain pipe through the levee 2-feet below the crown. Appears to connect to pump 150-feet off LS toe. Possible butterfly valve at LS toe. Vent on WS shoulder. Steel plate welded over pipe end on WS toe. FS Date: 9/5/2013

Possible Butterfly valve at LS toe.

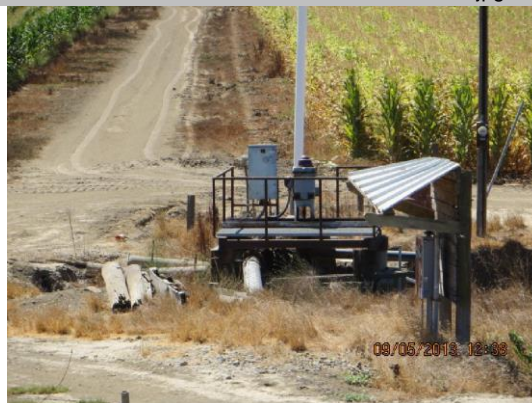
Photo 2 of 2 : UCIP\_FA\_2016\_19435\_32992.jpg

Possible connection at pump 150-feet off LS toe.

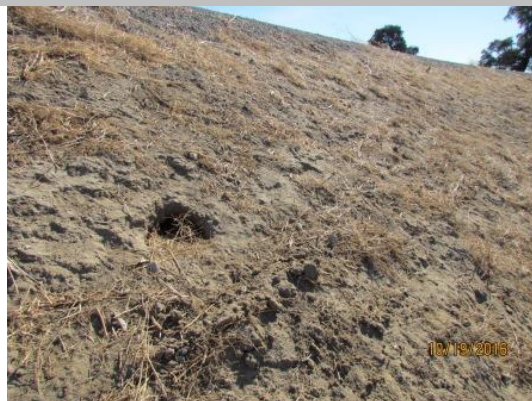
Photo 1 of 2 : FA\_2016\_RD2085\_113\_45\_20161024\_00050.jpg

LM Start	3.57	Rating **	M	Issue No.	45
LM End	3.57	Issue Type +	Ma	Location *	LS
Category	Earthen Levee			GPS Latitude/Longitude	
				Start	End
Item	Animal Control			37.690161 °	37.690161 °
				-121.276543 °	-121.276543 °
DWR ID	DWR_RD2085_01_s_2016_45				
Comment Code					
A3 : No rodents visible, but rodent burrows visible; need to backfill and compact or grout burrows.					
Inspector Comment

View of the rodent burrows on the landside levee slope. Fall 2016

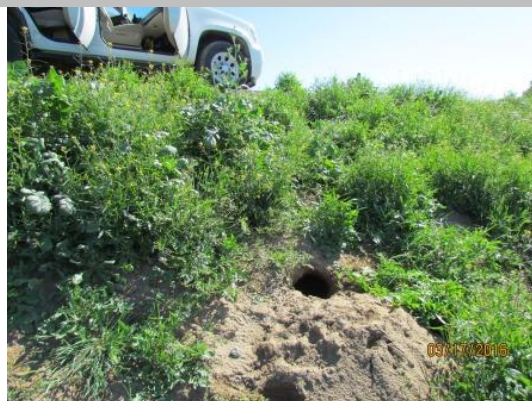
Photo 2 of 2 : FA\_2016\_RD2085\_113\_45\_20160914\_00018.jpg

View of the rodent burrows on the landside levee slope.

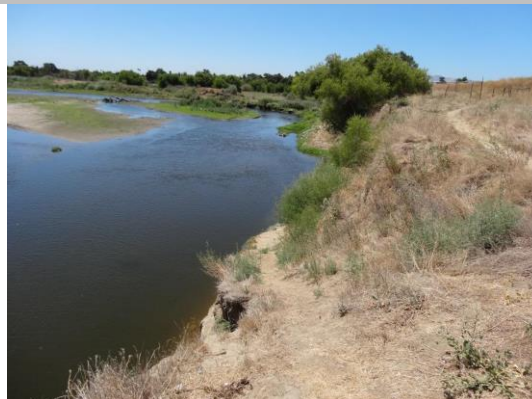
Photo 1 of 3 : SJR2016\_RD2085U01RM67.7\_1.jpg

07/08/2016: The erosion in the berm was found slightly progressed toward the levee toe. Signs of fresh erosion at the site are visible.  
 08/19/2015: No significant change observed.  
 07/17/2014: No significant change observed.  
 09/10/2013: No significant change observed.  
 12/04/2012: This site has been documented before, and a cost estimate to repair has been prepared dated 05/09/2010. The fresh cut shows the erosion is developing. The berm width is at least 42 feet. Sticks were placed at three locations along the river bank, with 3 sticks 5 feet apart at each location. [2016 Site ID:RD2085U01RM67.7]

View of the downstream end of the erosion.

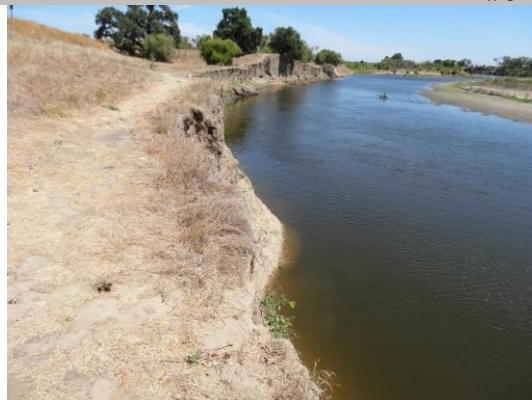
Photo 2 of 3 : SJR2016\_RD2085U01RM67.7\_2.jpg

Close view of the erosion.

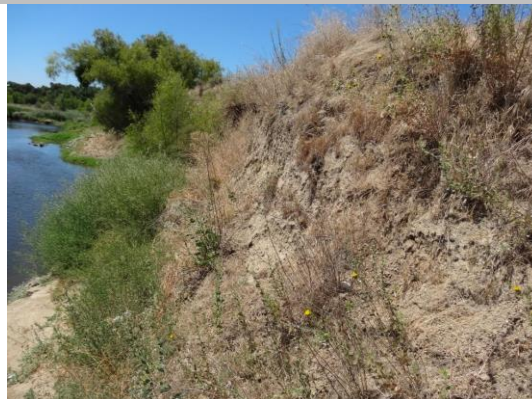
Photo 3 of 3 : SJR2016\_RD2085U01RM67.7\_4.jpg

Item	DWR Erosion Survey			37.688545 °	37.688545 °	
				-121.276298 °	-121.276298 °	
DWR ID						
Comment Code						
Inspector Comment						
07/08/2016: The erosion in the berm was found slightly progressed toward the levee toe. Signs of fresh erosion at the site are visible. 08/19/2015: No significant change observed. 07/17/2014: No significant change observed. 09/10/2013: No significant change observed. 12/04/2012: This site has been documented before, and a cost estimate to repair has been prepared dated 05/09/2010. The fresh cut shows the erosion is developing. The berm width is at least 42 feet. Sticks were placed at three locations along the river bank, with 3 sticks 5 feet apart at each location. [2016 Site ID:RD2085U01RM67.7]

Close view of the erosion.

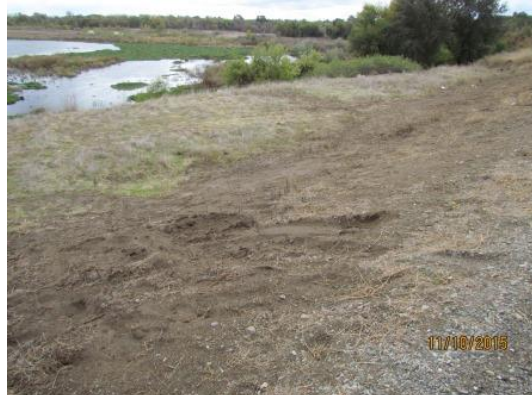
Photo 1 of 1 : FA\_2016\_RD2085\_113\_25\_20160914\_00009.jpg

LM Start	3.71	Rating **	A/W	Issue No.	25
LM End	3.71	Issue Type +	Ma	Location *	WS
Category	Earthen Levee			GPS Latitude/Longitude	
				Start	End
Item	Slope Stability			37.688216 °	37.688216 °
				-121.276603 °	-121.276603 °
DWR ID	DWR_RD2085_01_f_2015_25				
Comment Code					
S3 : Repair the levee slope damaged by vehicle traffic and prevent access where possible.					
Inspector Comment					
Control levee access to prevent damage to levee slopes by vehicle.

View of the waterside levee slope damaged by vehicle.

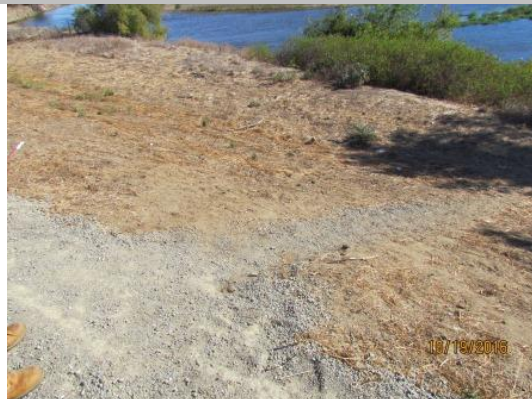
Photo 1 of 1 : FA\_2016\_RD2085\_113\_26\_20161024\_00049.jpg

LM Start	3.74	Rating **	A/W	Issue No.	26
LM End	3.74	Issue Type +	Ma	Location *	WS
Category	Earthen Levee			GPS Latitude/Longitude	
				Start	End
Item	Slope Stability			37.687841 °	37.687841 °
				-121.276678 °	-121.276678 °
DWR ID	DWR_RD2085_01_f_2015_26				
Comment Code					
S2 : Repair the levee slope damaged by foot traffic and prevent access where possible.					
Inspector Comment					
Area should be maintained to prevent further levee damage.

View of the foot path on the levee slope.

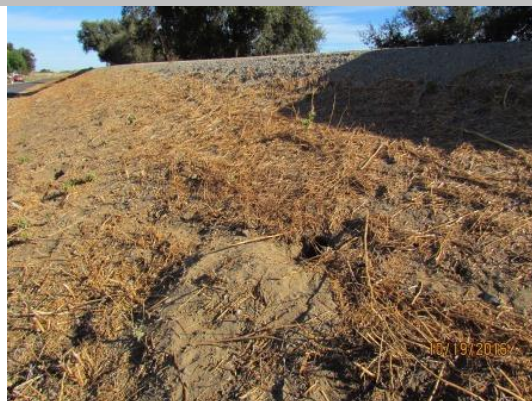
Photo 1 of 1 : FA\_2016\_RD2085\_113\_36\_20161024\_00048.jpg

View of the rodent holes on the levee slope.

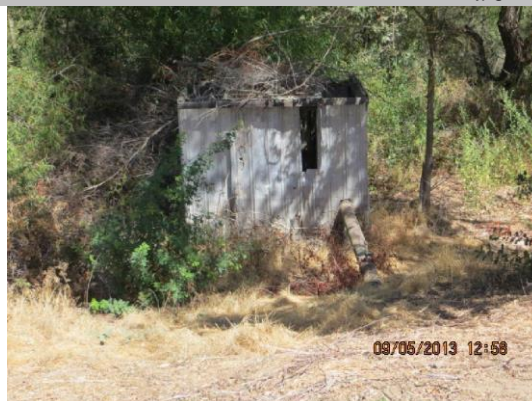
Photo 1 of 2 : UCIP\_FA\_2016\_19443\_33002.jpg

LM Start	4.03	Rating **	M	Issue No.	59
LM End	4.03	Issue Type +	En	Location *	LS
Category	Supplemental			GPS Latitude/Longitude	
				Start	End
Item	DWR UCIP Field Study			37.683642 °	37.683642 °
				-121.275792 °	-121.275792 °
DWR ID					
Comment Code					
Inspector Comment					
FS_ID:19443 DS_ID:20684 EP_NO: N/A Repair Type: Non-Urgent Crossing Status: Found UCIP Comments: This pipe appears abandoned and should be done so properly. FIELD_STRUCT_DESC: 6-inch steel irrigation pipe through the levee 4.0-feet below the crown. Pump house on the waterward berm. Siphon breaker in 24-inch corrugated metal riser unit on the landside shoulder. Vent on WS toe. 2-inch galvanized iron electrical conduit at same location. Originally included in the 1968 O&M manual. FS Date: 9/5/2013

Pumphouse and pipe visible on WS toe.

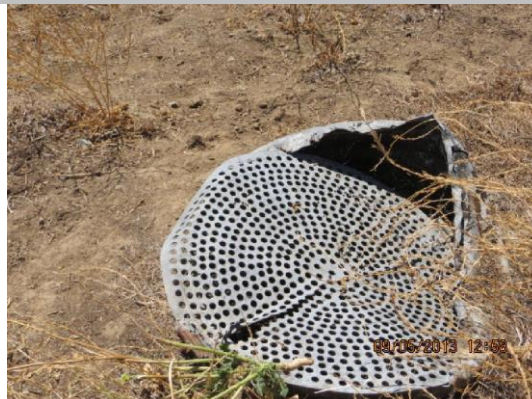
Photo 2 of 2 : UCIP\_FA\_2016\_19443\_33001.jpg

LM Start	4.03	Rating **	M	Issue No.	59 (cont)	
LM End	4.03	Issue Type +	En	Location *	LS	
Category	Supplemental			GPS Latitude/Longitude		
				Start		End
Item	DWR UCIP Field Study			37.683642 °	37.683642 °	
				-121.275792 °	-121.275792 °	
DWR ID						
Comment Code						
Inspector Comment						
FS_ID:19443 DS_ID:20684 EP_NO: N/A Repair Type: Non-Urgent Crossing Status: Found UCIP Comments: This pipe appears abandoned and should be done so properly. FIELD_STRUCT_DESC: 6-inch steel irrigation pipe through the levee 4.0-feet below the crown. Pump house on the waterward berm. Siphon breaker in 24-inch corrugated metal riser unit on the landside shoulder. Vent on WS toe. 2-inch galvanized iron electrical conduit at same location. Originally included in the 1968 O&M manual. FS Date: 9/5/2013

Siphon breaker on vent in 24-inch CMP riser on LS shoulder.

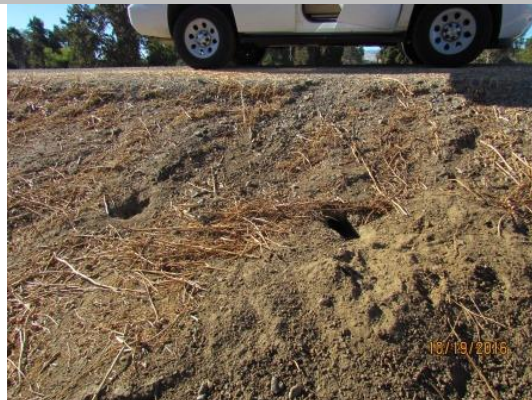
Photo 1 of 1 : FA\_2016\_RD2085\_113\_34\_20161024\_00047.jpg

LM Start	4.15	Rating **	M	Issue No.	34
LM End	4.15	Issue Type +	Ma	Location *	WS
Category	Earthen Levee			GPS Latitude/Longitude	
				Start	End
Item	Animal Control			37.682495 °	37.682495 °
				-121.274169 °	-121.274169 °
DWR ID	DWR_RD2085_01_f_2016_34				
Comment Code					
A3 : No rodents visible, but rodent burrows visible; need to backfill and compact or grout burrows.					
Inspector Comment

View of the rodent holes on the levee slope.

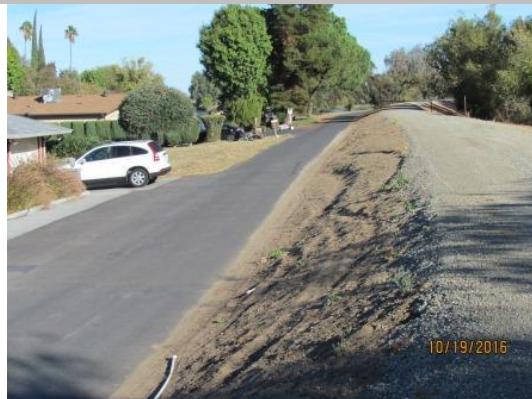
Photo 1 of 1 : FA\_2016\_RD2085\_113\_52\_20161024\_00044.jpg

LM Start	5.20	Rating **	M	Issue No.	52
LM End	5.20	Issue Type +	Ma	Location *	LS
Category	Earthen Levee			GPS Latitude/Longitude	
				Start	End
Item	Slope Stability			37.675620 °	37.675620 °
				-121.269359 °	-121.269359 °
DWR ID	DWR_RD2085_01_s_2016_52				
Comment Code					
S3 : Repair the levee slope damaged by vehicle traffic and prevent access where possible.					
Inspector Comment

View of the tire tracks on the levee slope.

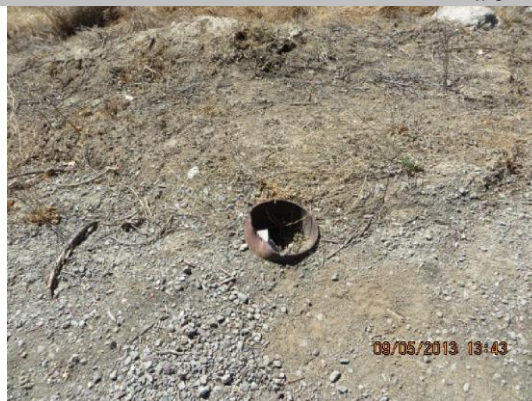
Photo 1 of 2 : UCIP\_FA\_2016\_22290\_38020.jpg

LM Start	5.23	Rating **	M	Issue No.	54
LM End	5.23	Issue Type +	En	Location *	LS
Category	Supplemental			GPS Latitude/Longitude	
				Start	End
Item	DWR UCIP Field Study			37.675244 °	37.675244 °
				-121.269287 °	-121.269287 °
DWR ID					
Comment Code					
Inspector Comment					
FS_ID:22290					
DS_ID:24058					
EP_NO: N/A					
Repair Type: Non-Urgent					
Crossing Status: Found					
UCIP Comments: No permit identified for this crossing.					
FIELD_STRUCT_DESC: 10-inch steel irrigation pipe through the levee at unknown depth below the crown. Siphon breaker in 10-inch steel riser on LS shoulder.					
FS Date: 9/10/2013

Siphon breaker in 10-inch steel riser on LS shoulder.

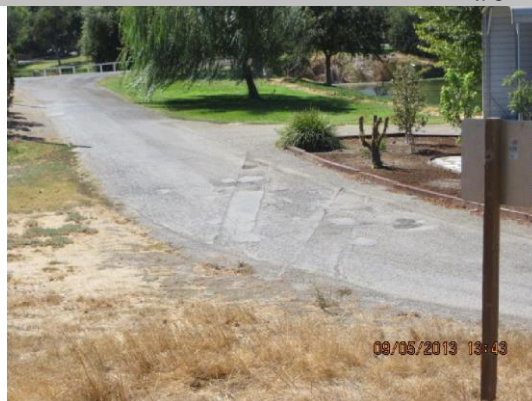
Photo 2 of 2 : UCIP\_FA\_2016\_22290\_38019.jpg

LM Start	5.23	Rating **	M	Issue No.	54 (cont)
LM End	5.23	Issue Type +	En	Location *	LS
Category	Supplemental			GPS Latitude/Longitude	
				Start	End
Item	DWR UCIP Field Study			37.675244 °	37.675244 °
				-121.269287 °	-121.269287 °
DWR ID					
Comment Code					
Inspector Comment					
FS_ID:22290 DS_ID:24058 EP_NO: N/A Repair Type: Non-Urgent Crossing Status: Found UCIP Comments: No permit identified for this crossing. FIELD_STRUCT_DESC: 10-inch steel irrigation pipe through the levee at unknown depth below the crown. Siphon breaker in 10-inch steel riser on LS shoulder. FS Date: 9/10/2013

Cuts in pavement may indicate alignment of pipe at LS toe.

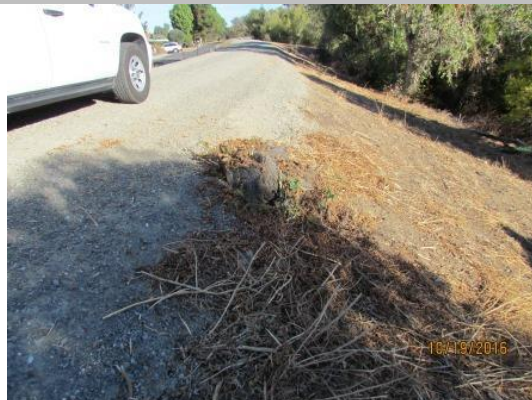
Photo 1 of 1 : FA\_2016\_RD2085\_113\_29\_20161024\_00043.jpg

LM Start	5.24	Rating **	N	Issue No.	29
LM End	5.24	Issue Type +	Ma	Location *	WS
Category	Earthen Levee			GPS Latitude/Longitude	
				Start	End
Item	Trim / Thin Trees			37.675099 °	37.675099 °
				-121.269264 °	-121.269264 °
DWR ID	DWR_RD2085_01_f _ 2015_29				
Comment Code					
T5 : Tree stumps.					
Inspector Comment

View of the tree stump.

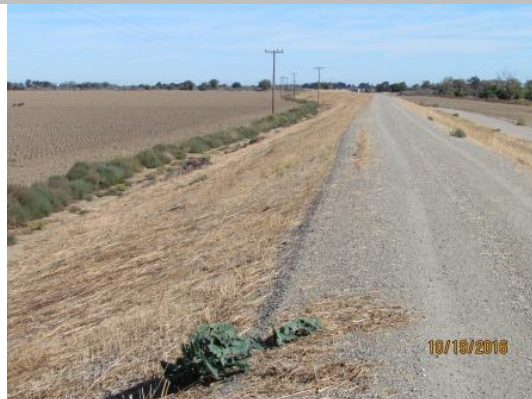
Photo 1 of 1 : FA\_2016\_RD2085\_114\_1\_20161024\_00001.jpg

View of the well maintained vegetation on the levee slope.

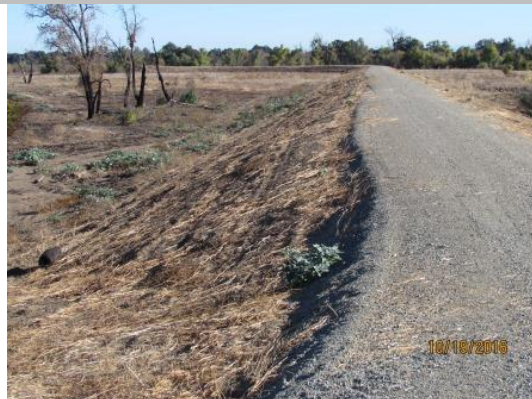
Photo 1 of 1 : FA\_2016\_RD2085\_115\_4\_20161024\_00002.jpg

View of the well maintained vegetation on the levee slope.

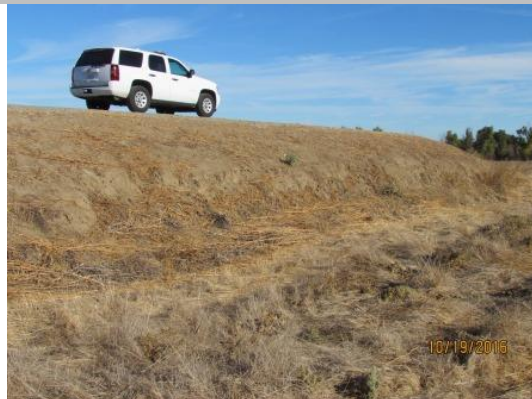
Photo 1 of 2 : FA\_2016\_RD2085\_115\_1\_20161024\_00003.jpg

LM Start	0.21	Rating **	U	Issue No.	1
LM End	0.23	Issue Type +	Ma	Location *	WS
Category	Earthen Levee			GPS Latitude/Longitude	
				Start	End
Item	Erosion / Bank Caving			37.682798 °	37.683052 °
				-121.262059 °	-121.261851 °
DWR ID	DWR_RD2085_03_s_2014_1				
Comment Code					
E2 : Schedule repair of erosion site prior to the next inspection.					
Inspector Comment					
Erosion of the waterside levee slope has been observed. The erosion is about 3 feet tall vertical from the slope to the base of projected levee toe.

View of the erosion at the waterside levee toe. Fall 2016.

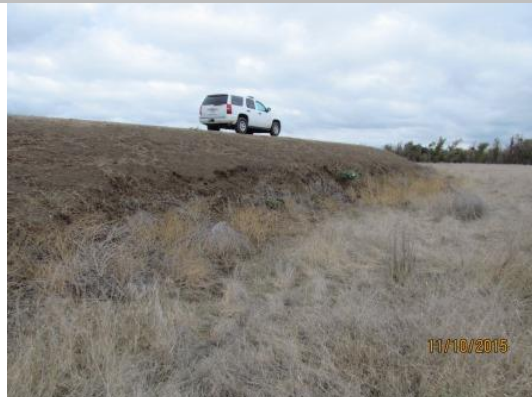
Photo 2 of 2 : FA\_2016\_RD2085\_115\_1\_20160914\_00001.jpg

View of the erosion at the waterside levee toe.

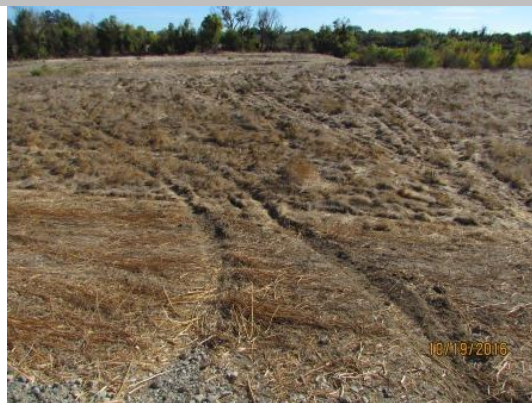
Photo 1 of 1 : FA\_2016\_RD2085\_115\_7\_20161024\_00004.jpg

LM Start	0.25	Rating **	M	Issue No.	7
LM End	0.25	Issue Type +	Ma	Location *	WS
Category	Earthen Levee			GPS Latitude/Longitude	
				Start	End
Item	Slope Stability			37.683274 °	37.683274 °
				-121.261839 °	-121.261839 °
DWR ID	DWR_RD2085_03_f_2016_7				
Comment Code					
S3 : Repair the levee slope damaged by vehicle traffic and prevent access where possible.					
Inspector Comment

View of the tire tracks on the levee slope.
